**RECONNAISSANCE TRIP REPORT
FOR THE
UNITED STATES METAL PRODUCTS COMPANY
ERIE, ERIE COUNTY, PENNSYLVANIA**

U.S. Environmental Protection Agency Region 3
Hazardous Property Cleanup Division
1650 Arch Street
Philadelphia, PA 19103

Tetra Tech EM Inc.
100 Enterprise Drive, Suite 400
Rockaway, NJ 07866

September 12, 2005

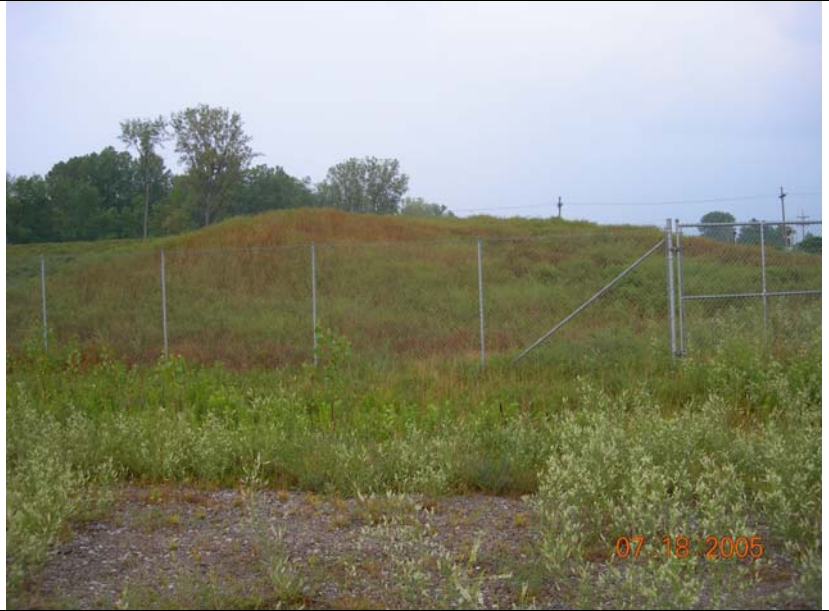
Photo 1:

Location of site at the intersection of Filmore Avenue and W. 18th Street; mound of unknown material covered with vegetation; mound surrounded by fence

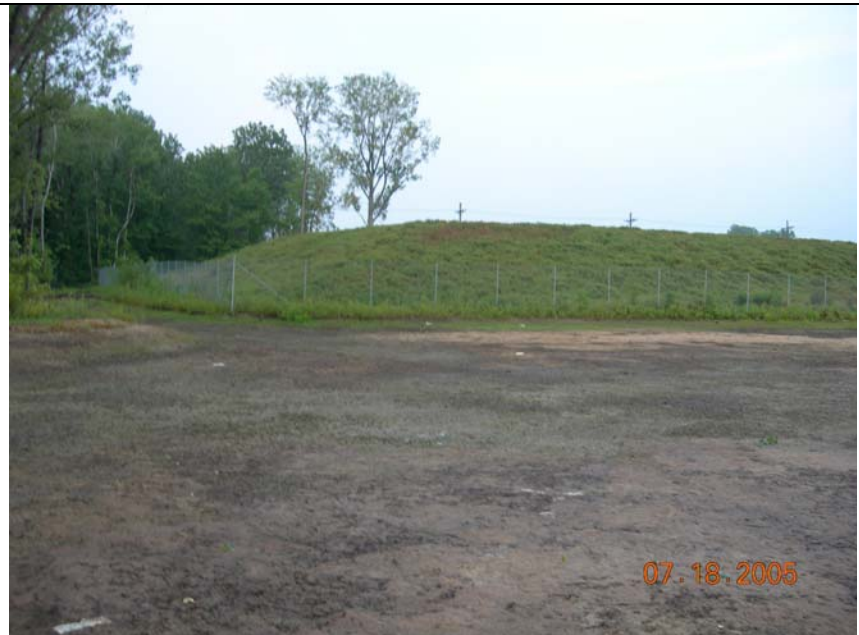
Photo 2:

Excavated area; fenced mound of unknown material covered with vegetation

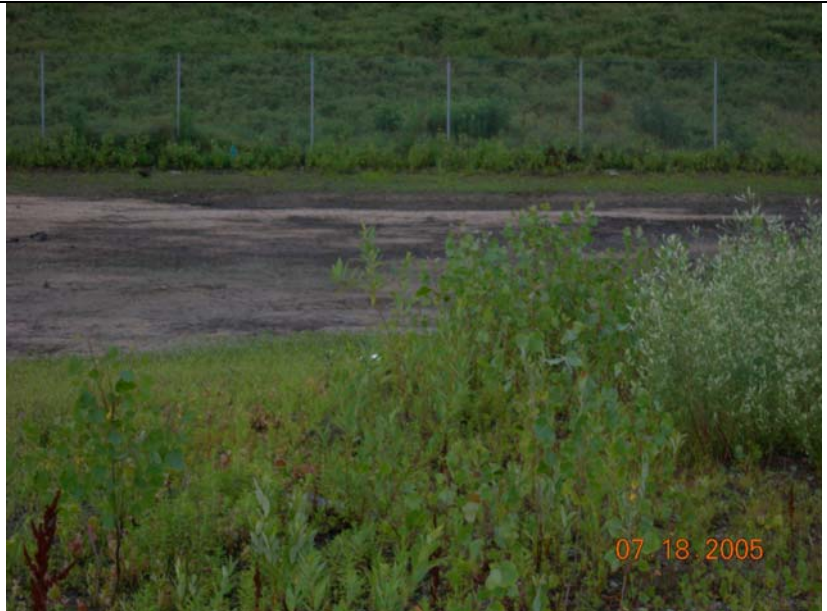
Photo 3:
Excavated area

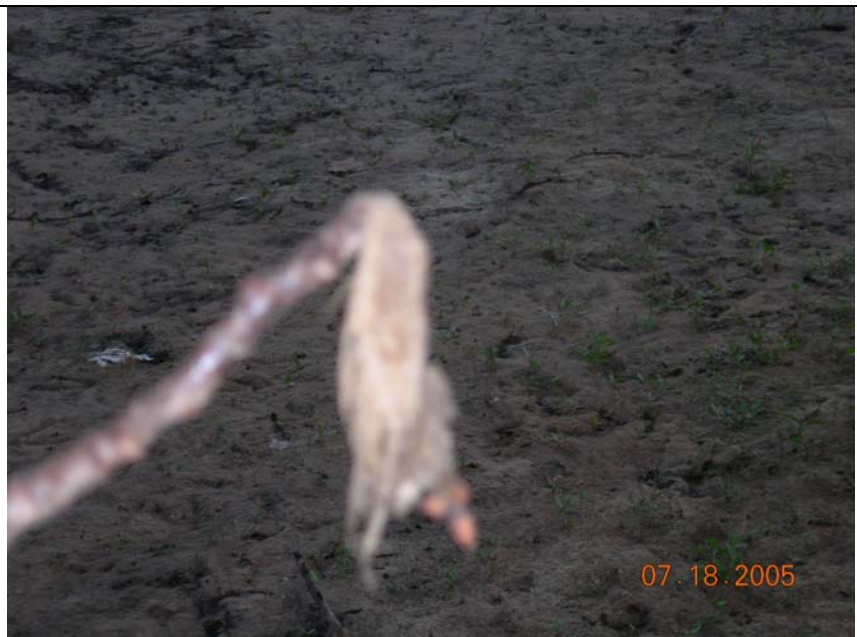
- The property consists of two sections. On the west and north sides of the property is an excavation covered with soil stabilization fabric. The soil stabilization fabric is decomposing and there is no vegetation growing on this area. The excavation appears to be approximately four feet deep. On the east and south sides of the property is a large pile of unknown material which is covered with vegetation. The pile of unknown material is surrounded by a fence. It appears that the material excavated from the property was made into a pile adjacent to the excavation and then a fence was constructed around the pile.

Photo 4:
Soil stabilization fabric
covering excavated area

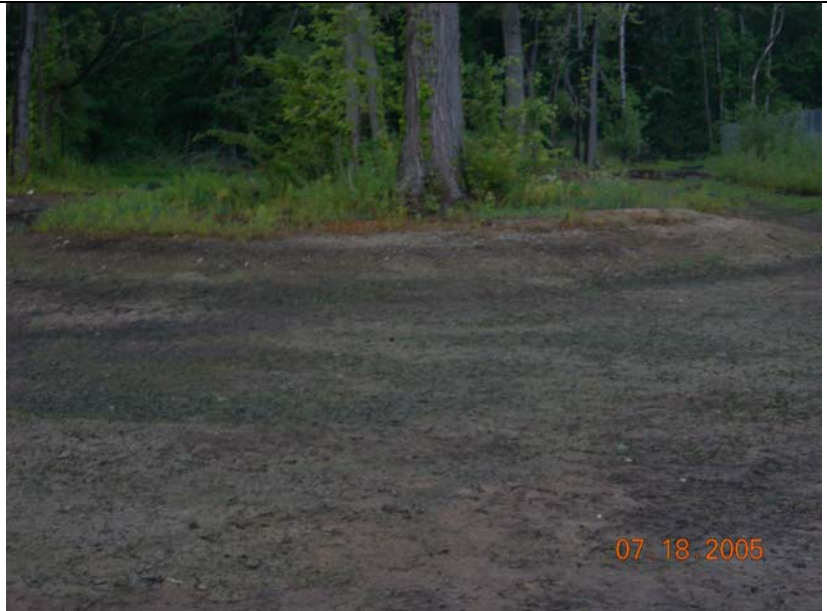
Photo 5:

Excavated area with soil
stabilization fabric cover

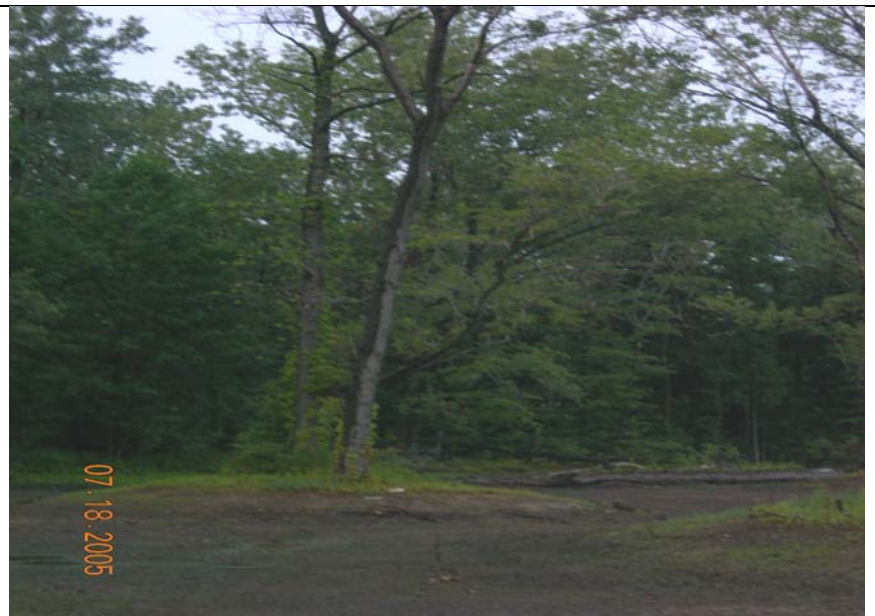
Photo 6:

Excavated area with soil
stabilization fabric cover

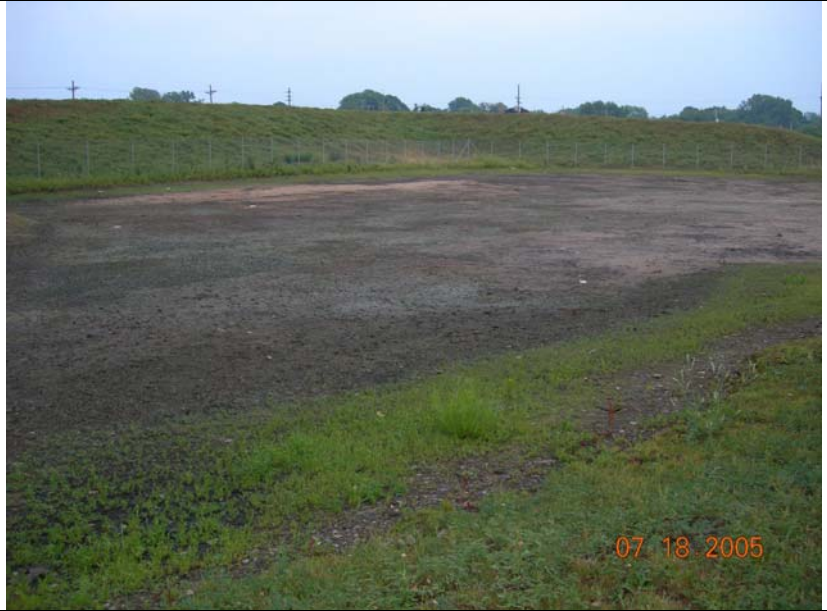
Photo 7:

Excavated area with soil stabilization fabric cover; fenced mound of unknown material

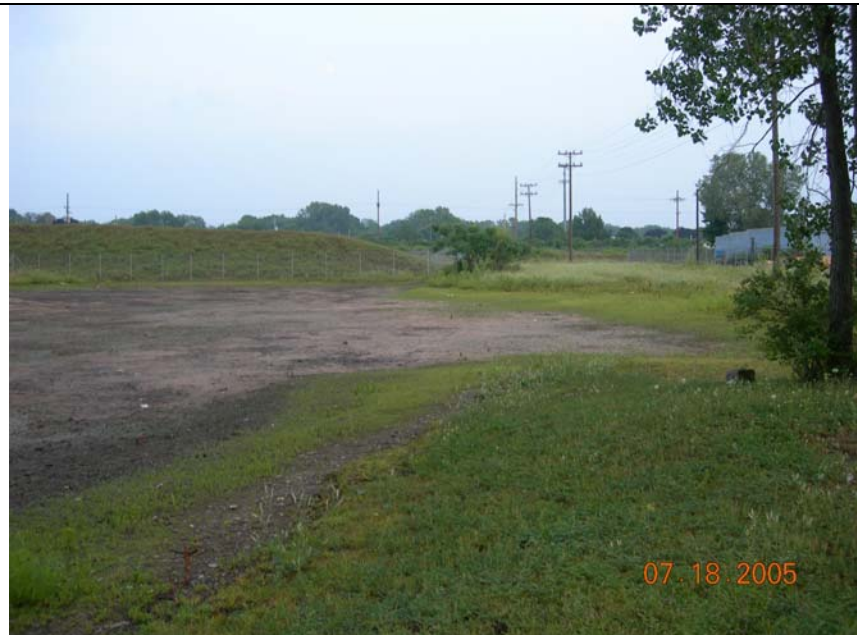
Photo 8:

Excavated area with soil stabilization fabric cover; fenced mound of unknown material

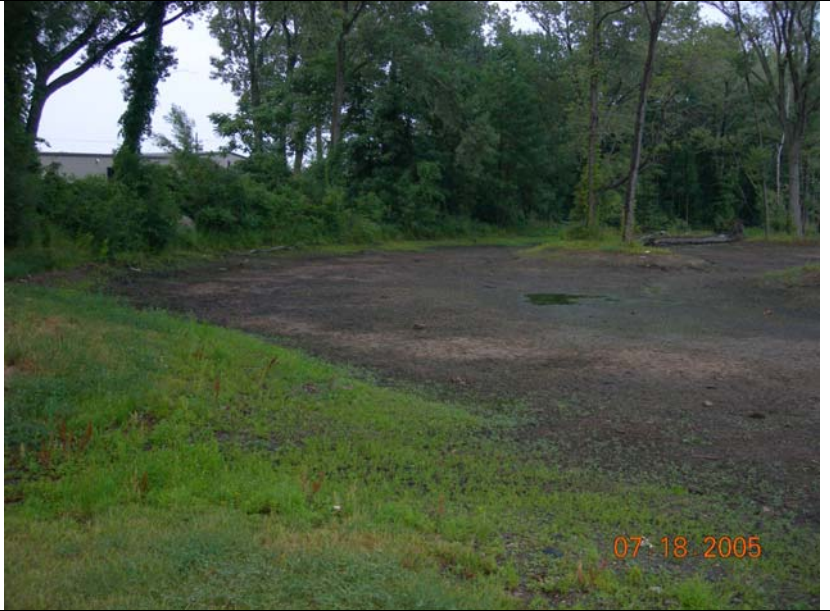
Photo 9:

Excavated area with soil stabilization fabric cover; Industrial Recision Services Inc. building to northeast of site

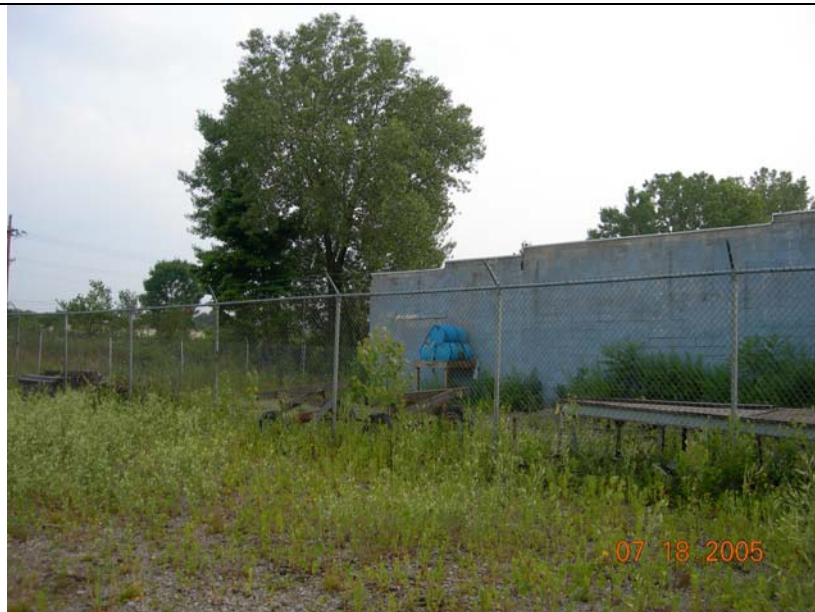
Photo 10:

LOC Inc. lumberyard to the west of the site; property is fenced

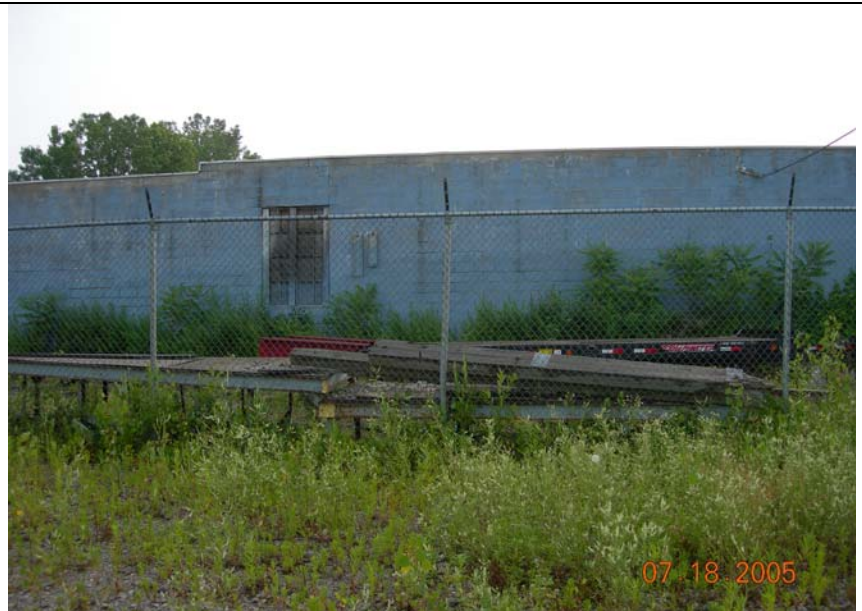
Photo 11:

LOC Inc. lumberyard to
the west of the site;
property is fenced

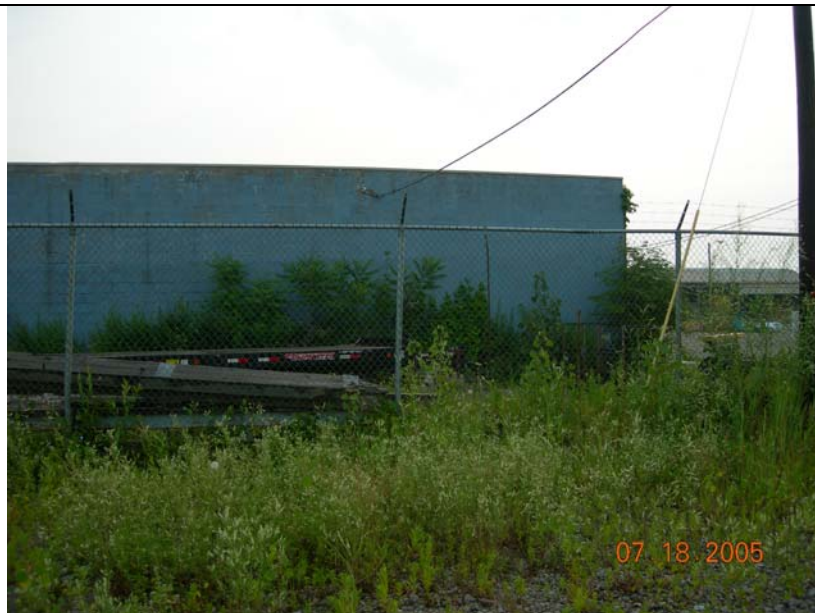
Photo 12:

LOC Inc. lumberyard to
the west of the site;
property is fenced

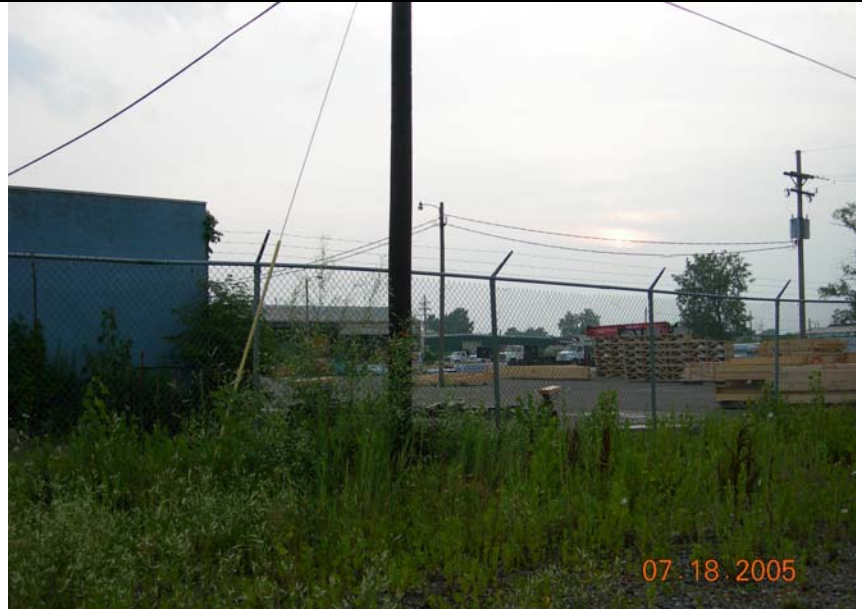
Photo 13:

LOC Inc. lumberyard to
the west of the site;
property is fenced

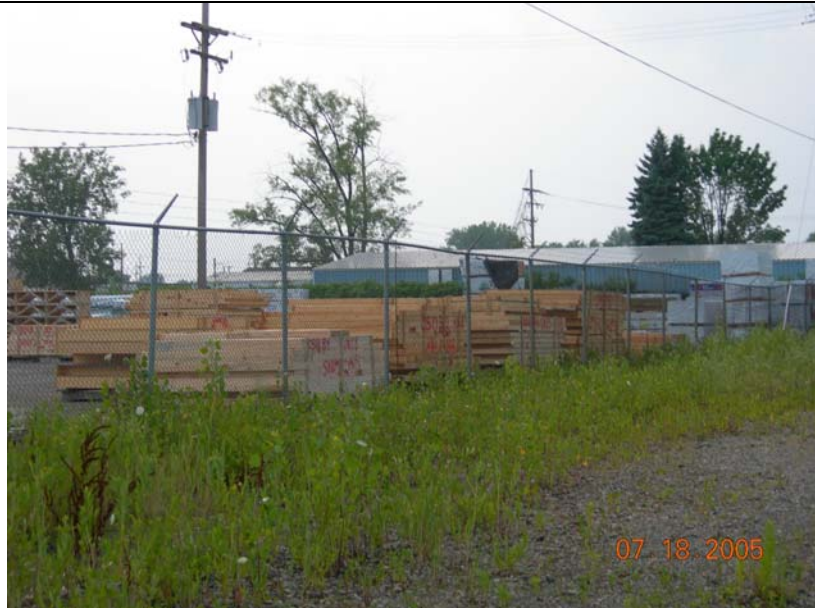
Photo 14:

LOC Inc. lumberyard to
the west of the site;
property is fenced

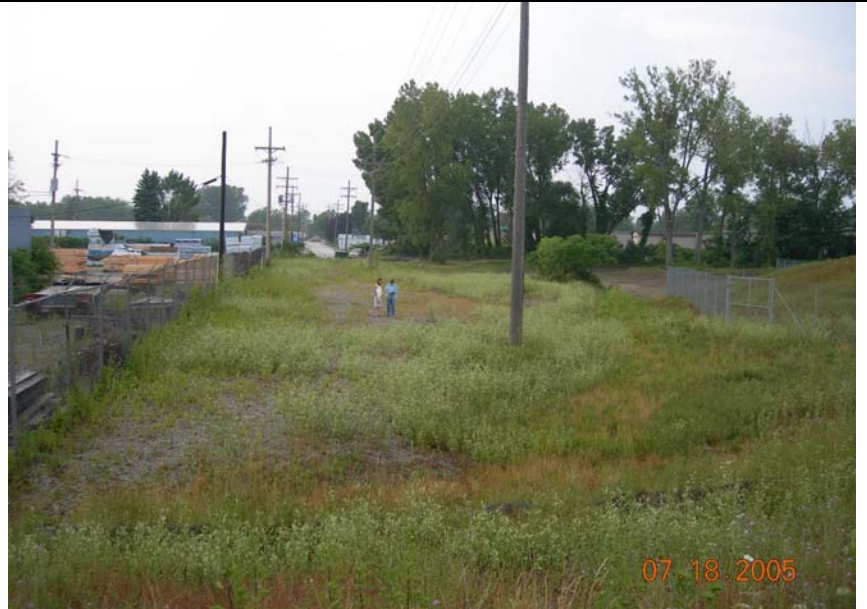
Photo 15:

Location of site and
LOC Inc. lumberyard to
the west of the site;
powerlines run along
side the site and down
Fillmore Avenue

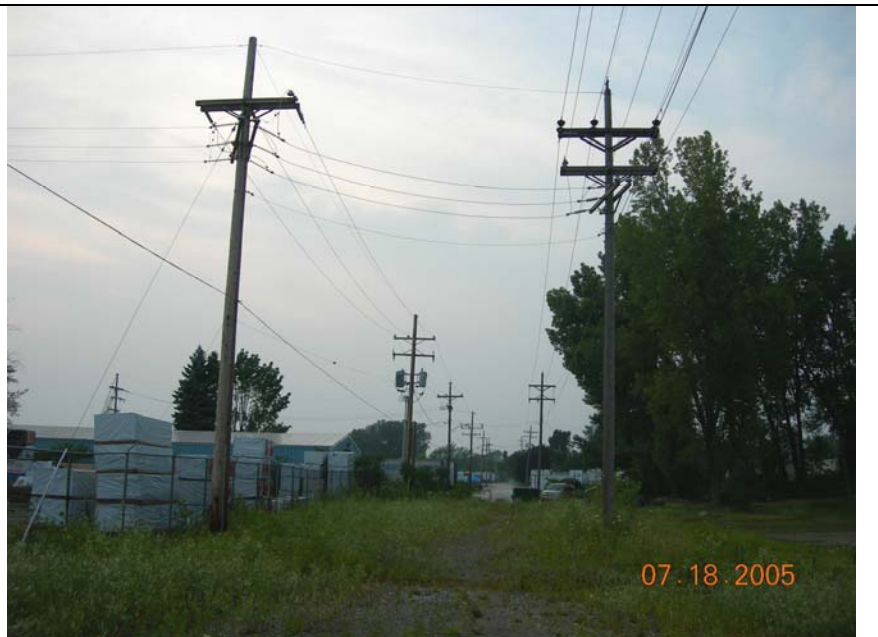
Photo 16:

Location of site and
LOC Inc. lumberyard to
the west of the site;
powerlines run along
side the site and down
Fillmore Avenue

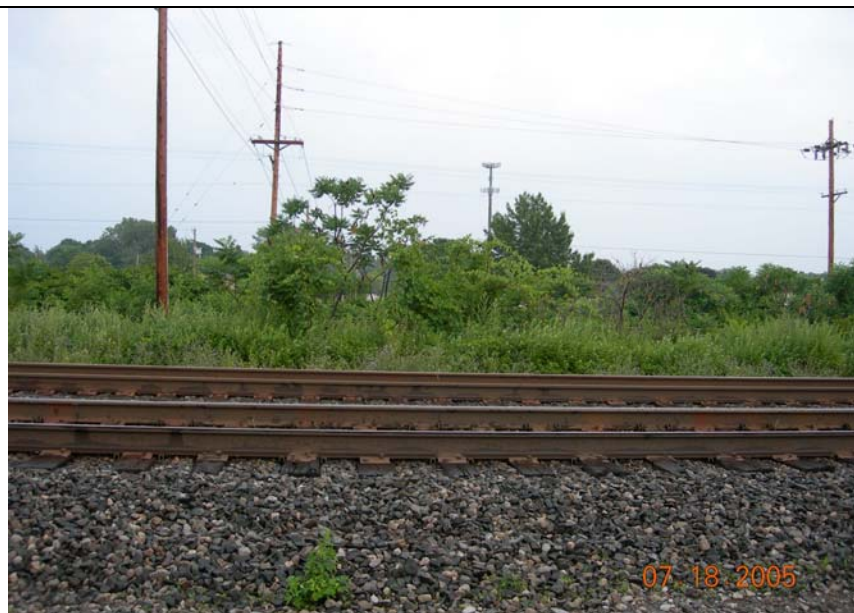
Photo 17:
Railroad Tracks south of
site

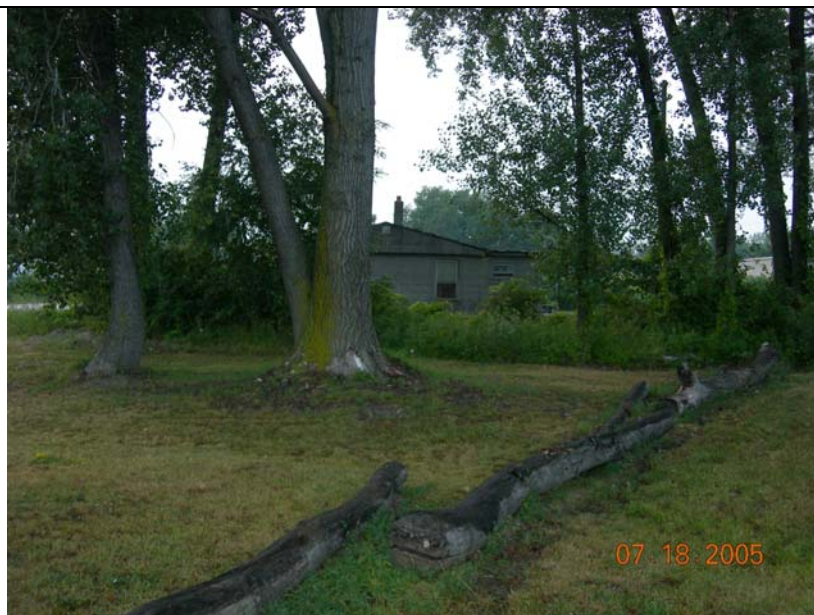
- There is one residence within 100 feet of the north edge of the excavation at the intersection of Filmore Street and West 18th Street. The residential property is surrounded by a fence on the north, east and south sides.

Photo 18:
House north of the site

- It cannot be determined with available information if lead smelting activities occurred on the site; therefore, to determine if the soils located at the nearby residential house were impacted, soil sampling should be completed.

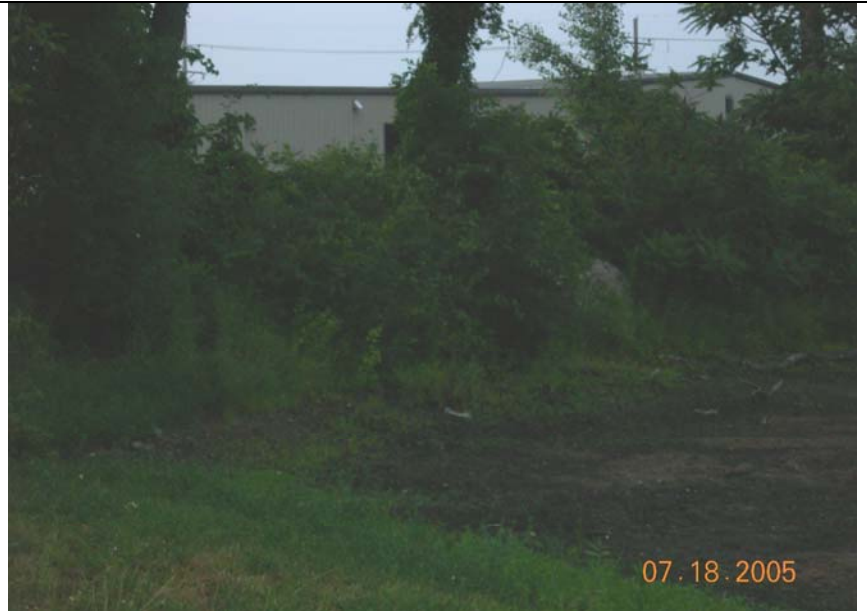
Photo 19:
Industrial Recision
Services Inc. to the
northeast of site

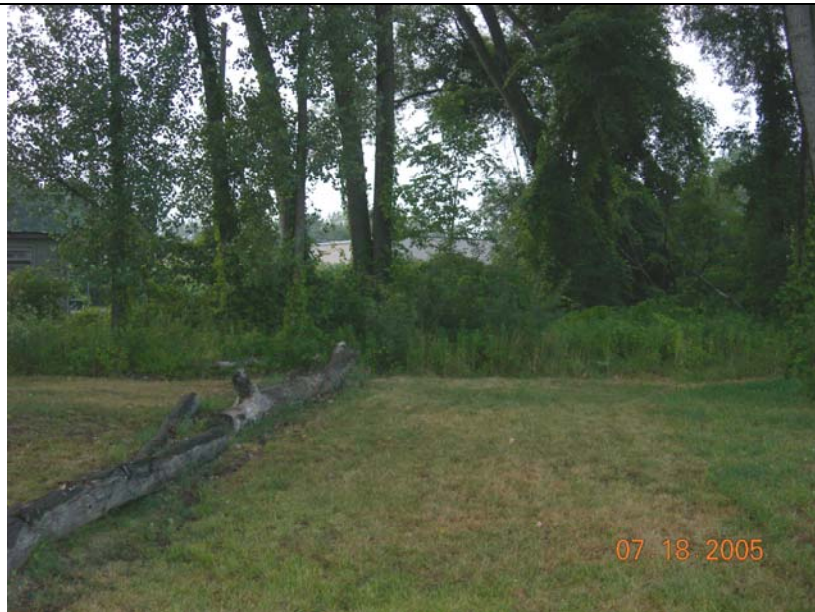
Photo 20:
House and Industrial
Recision Services Inc. to
the north/northeast of
site

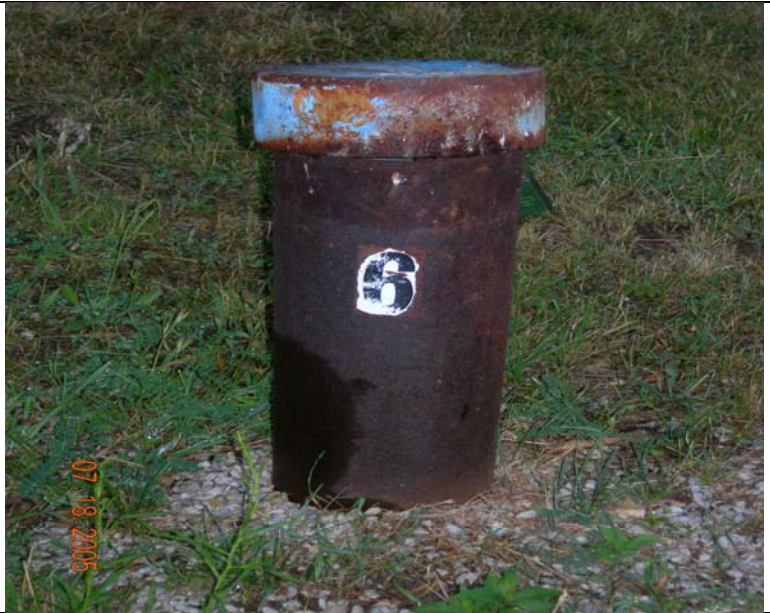
- There is a picnic table approximately 50 feet from the northwest edge of the excavation.
- There is a monitoring well approximately 50 feet from the northwest edge of the excavation.

Photo 21:
Monitoring well to the
northwest of site

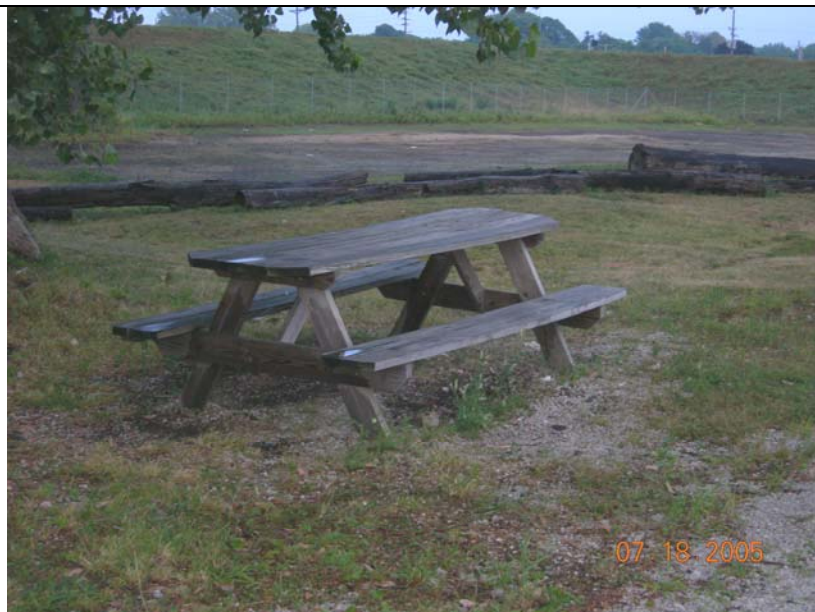
Photo 22:
Picnic table to the
northwest of site

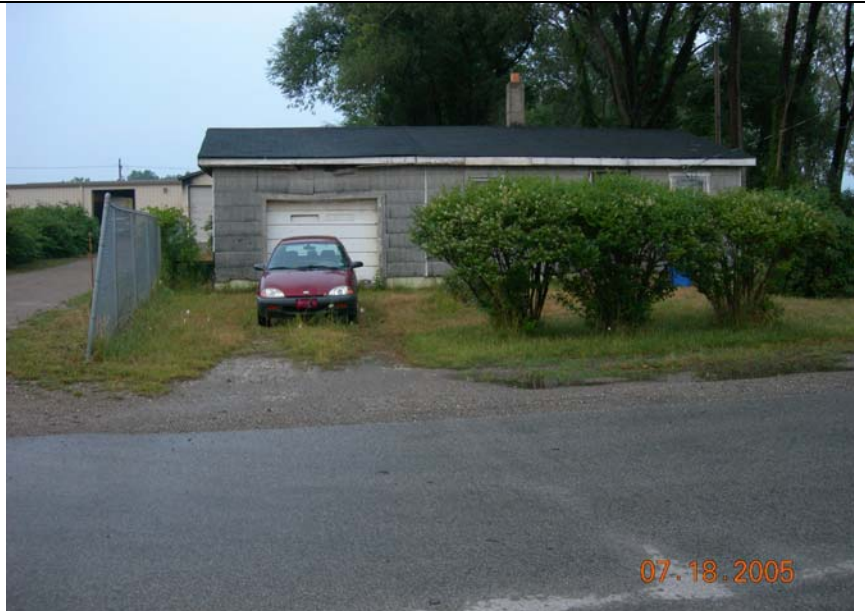
Photo 23:

House to the north of the site; property is fenced on three sides

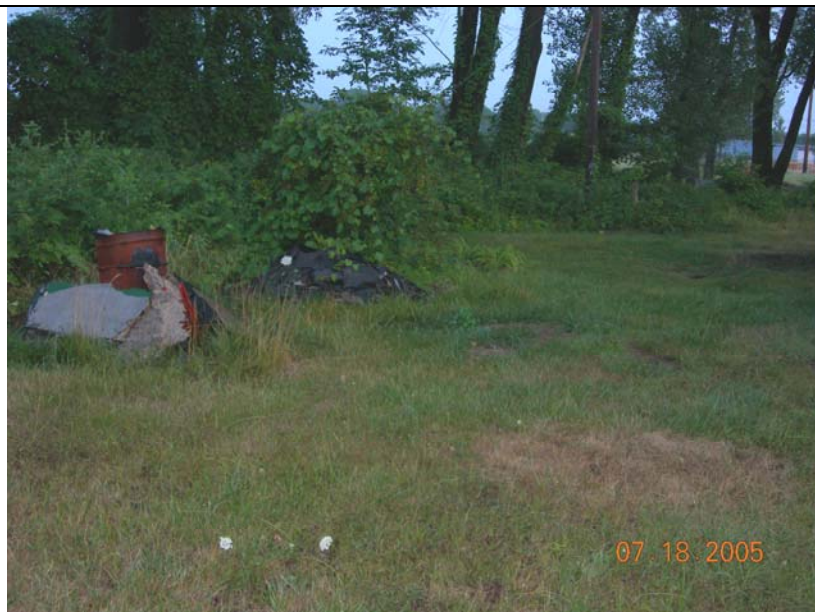
Photo 24:

Backyard of house north of the site

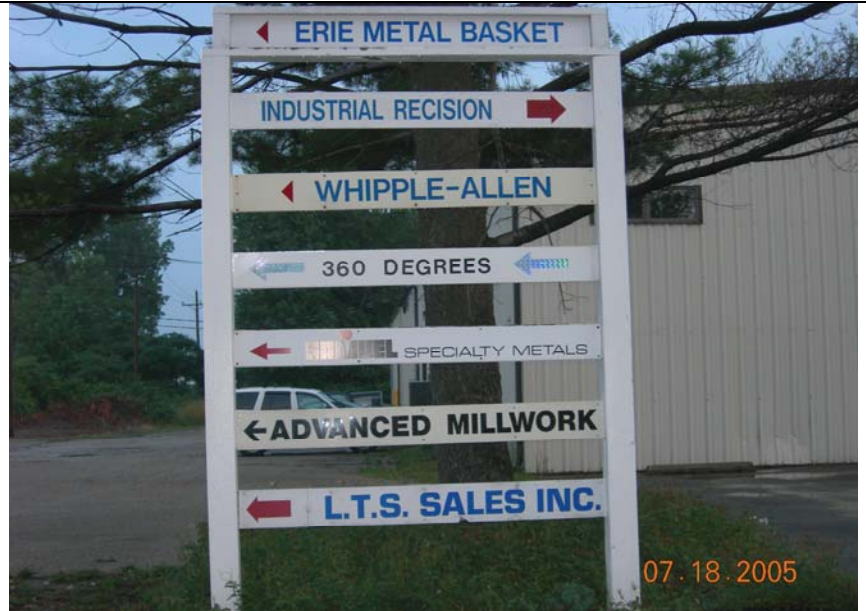
Photo 25:

Sign for industrial complex located north/northeast of the site

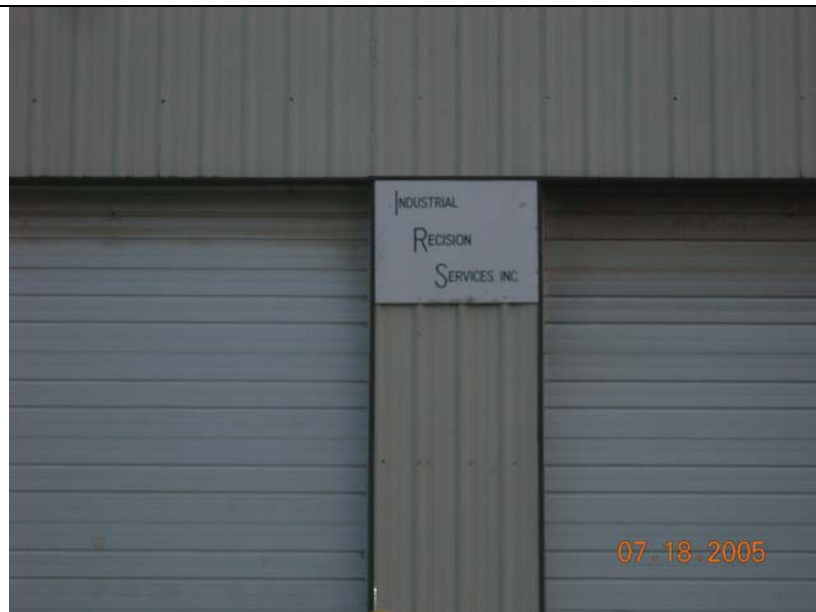
Photo 26:

Industrial Recision Services, Inc. building and sign

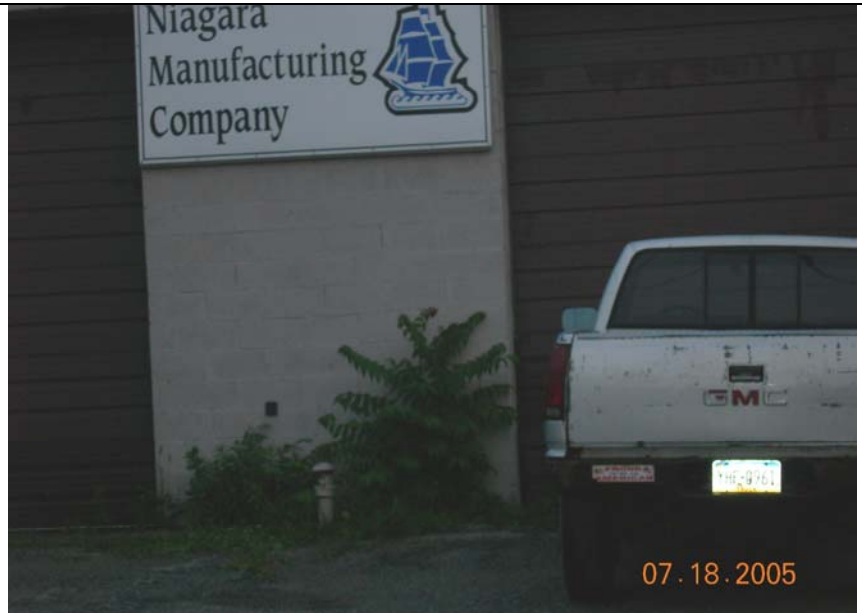
Photo 27:
Niagara Manufacturing
Company to the
northeast of the site

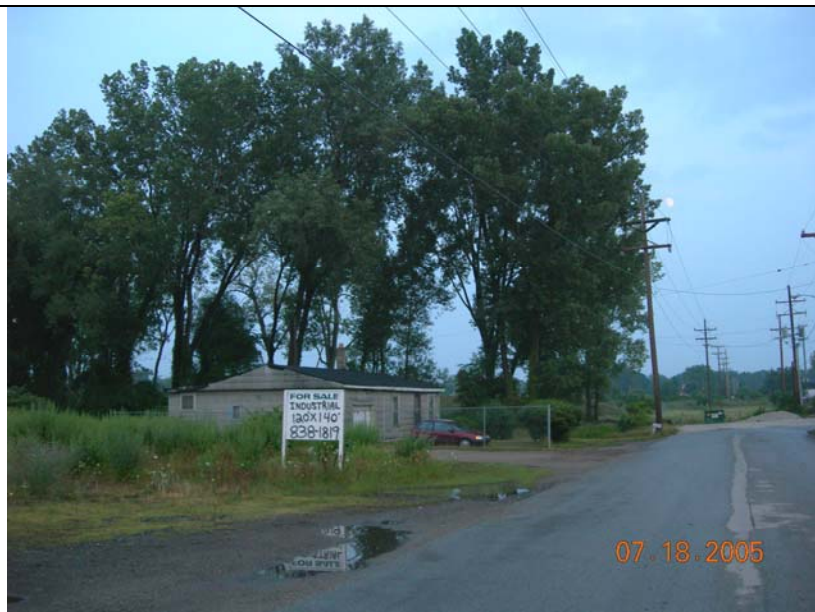
Photo 28:
House on Filmore
Avenue to the north of
the site; Filmore Avenue

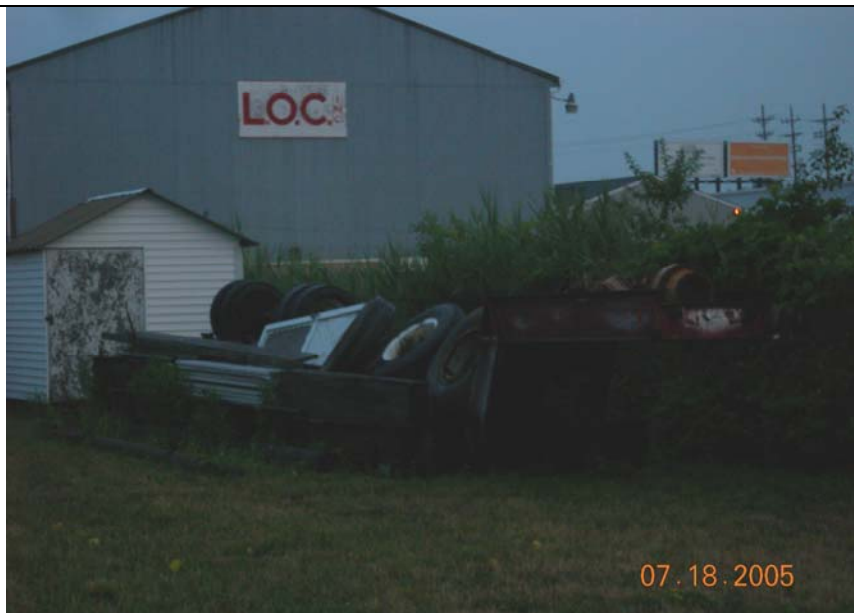
Photo 29:
L.O.C. Inc. lumber yard
sign
